**RCRA FACILITY INVESTIGATION**  
**DU PONT EXPERIMENTAL STATION**  
**DRAFT FINAL REPORT**

**RCRA FACILITY INVESTIGATION  
DuPont EXPERIMENTAL STATION  
DRAFT FINAL REPORT**

**GeoTrans, Inc.  
46050 Manekin Plaza  
Suite 100  
Sterling, Virginia 22170**

**GeoTrans Project No. 8788-000**

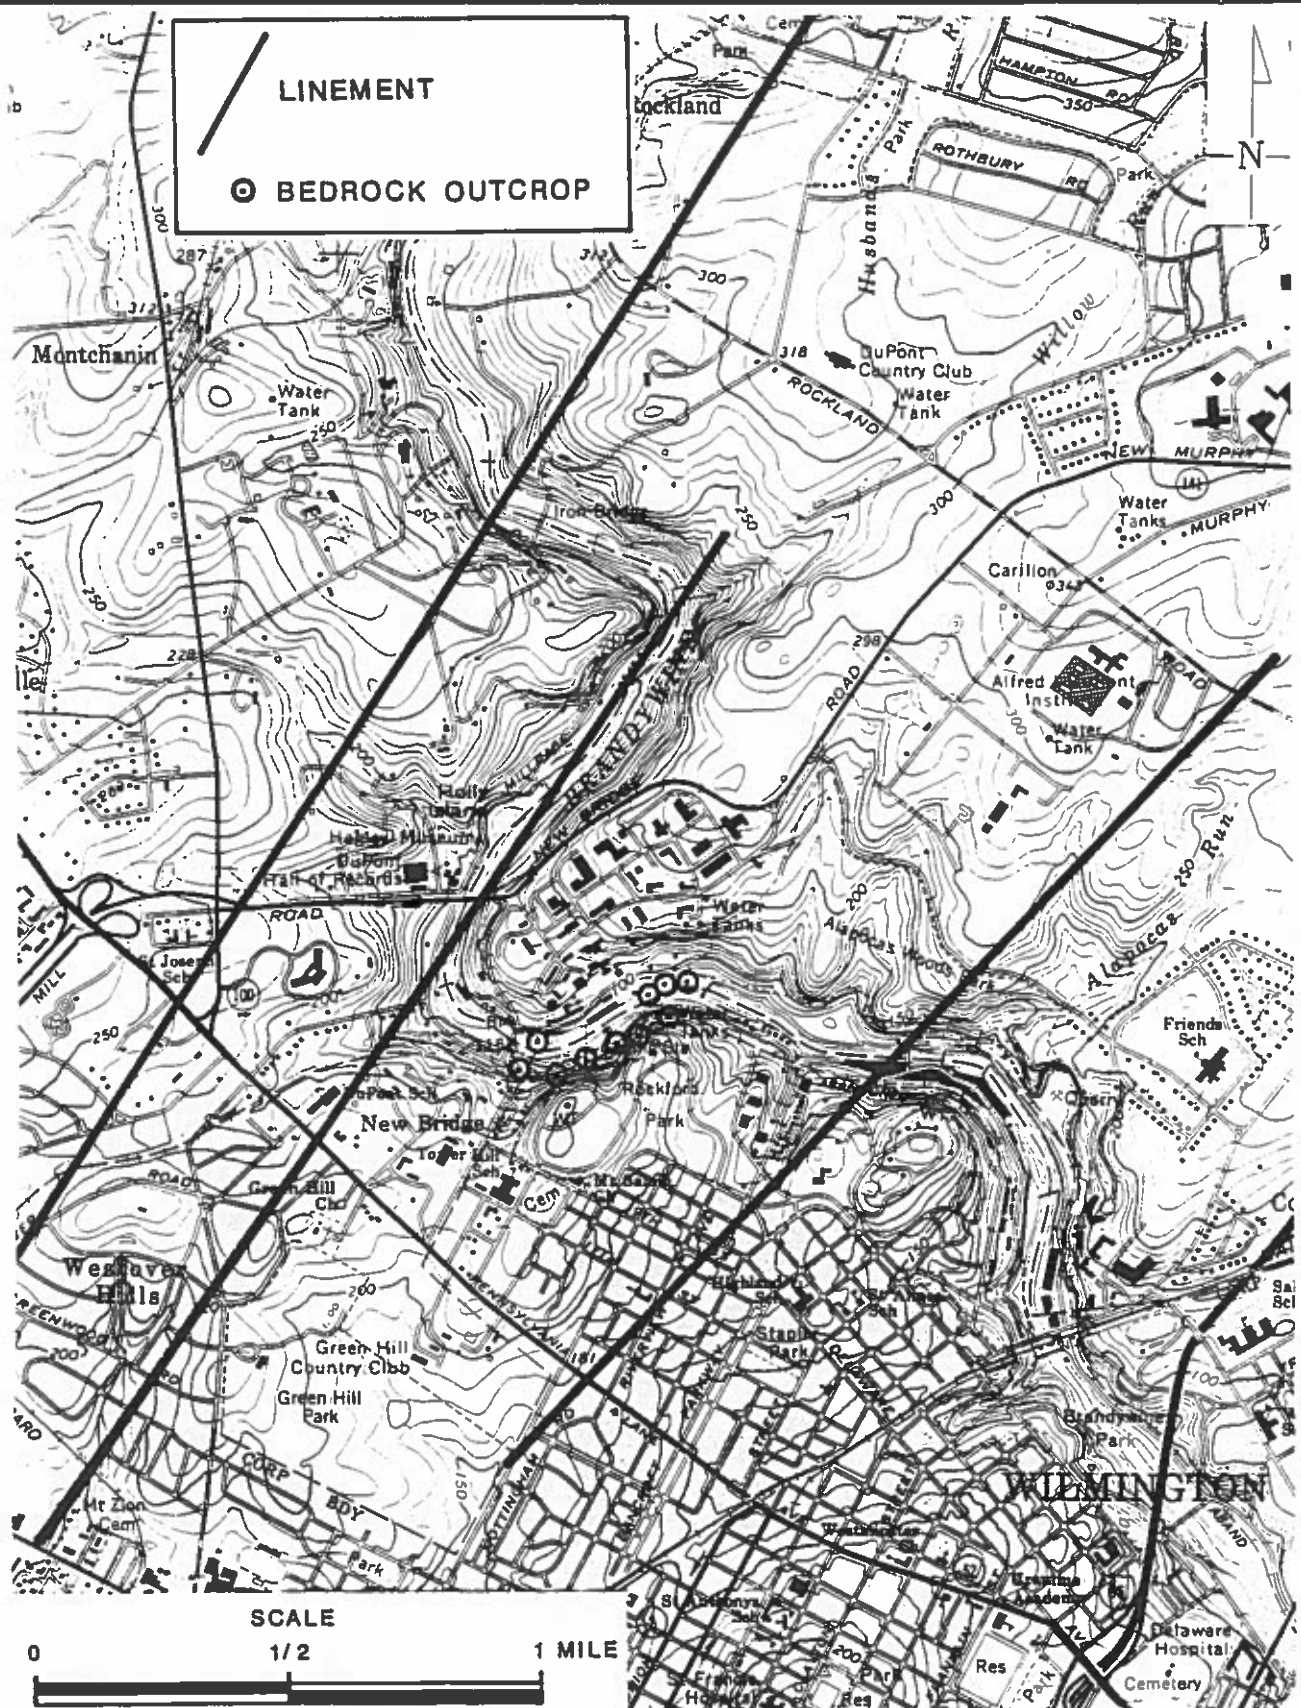
Figure 4.1. Linements in the vicinity of the DuPont Experimental Station.

Of the three lineaments depicted, the one coincident with a reach of the Brandywine Creek was discussed in detail by Dressel (1989). This lineament, known as the Brandywine/Hagley lineament, is approximately 3 km in length and is composed of both a physiographic segment (coincident with the Brandywine) and a tonal segment extending to the southwest. Dressel recognized two joint sets centered at 022° and 285° in five outcrops located along the trace of the lineament. Dressel recognized that the 022° joint set was nearly parallel to the azimuth of the Brandywine/Hagley lineament (029°). The 285° joint set was also recognized to be nearly parallel to the section of the Brandywine Creek located immediately upstream. Based on this evidence, as well as other evidence in the Delaware Piedmont, Dressel (1989) concluded that stream morphology was probably controlled by joint patterns.

A structural analysis of the fracture patterns in bedrock outcrops along the section of the Brandywine Creek south of the Experimental Station was completed for the RFI. Field mapping was performed (using a Brunton Compass) on rocks cropping out on both the north and the south side of the creek in publicly accessible areas (Figure 4.1).

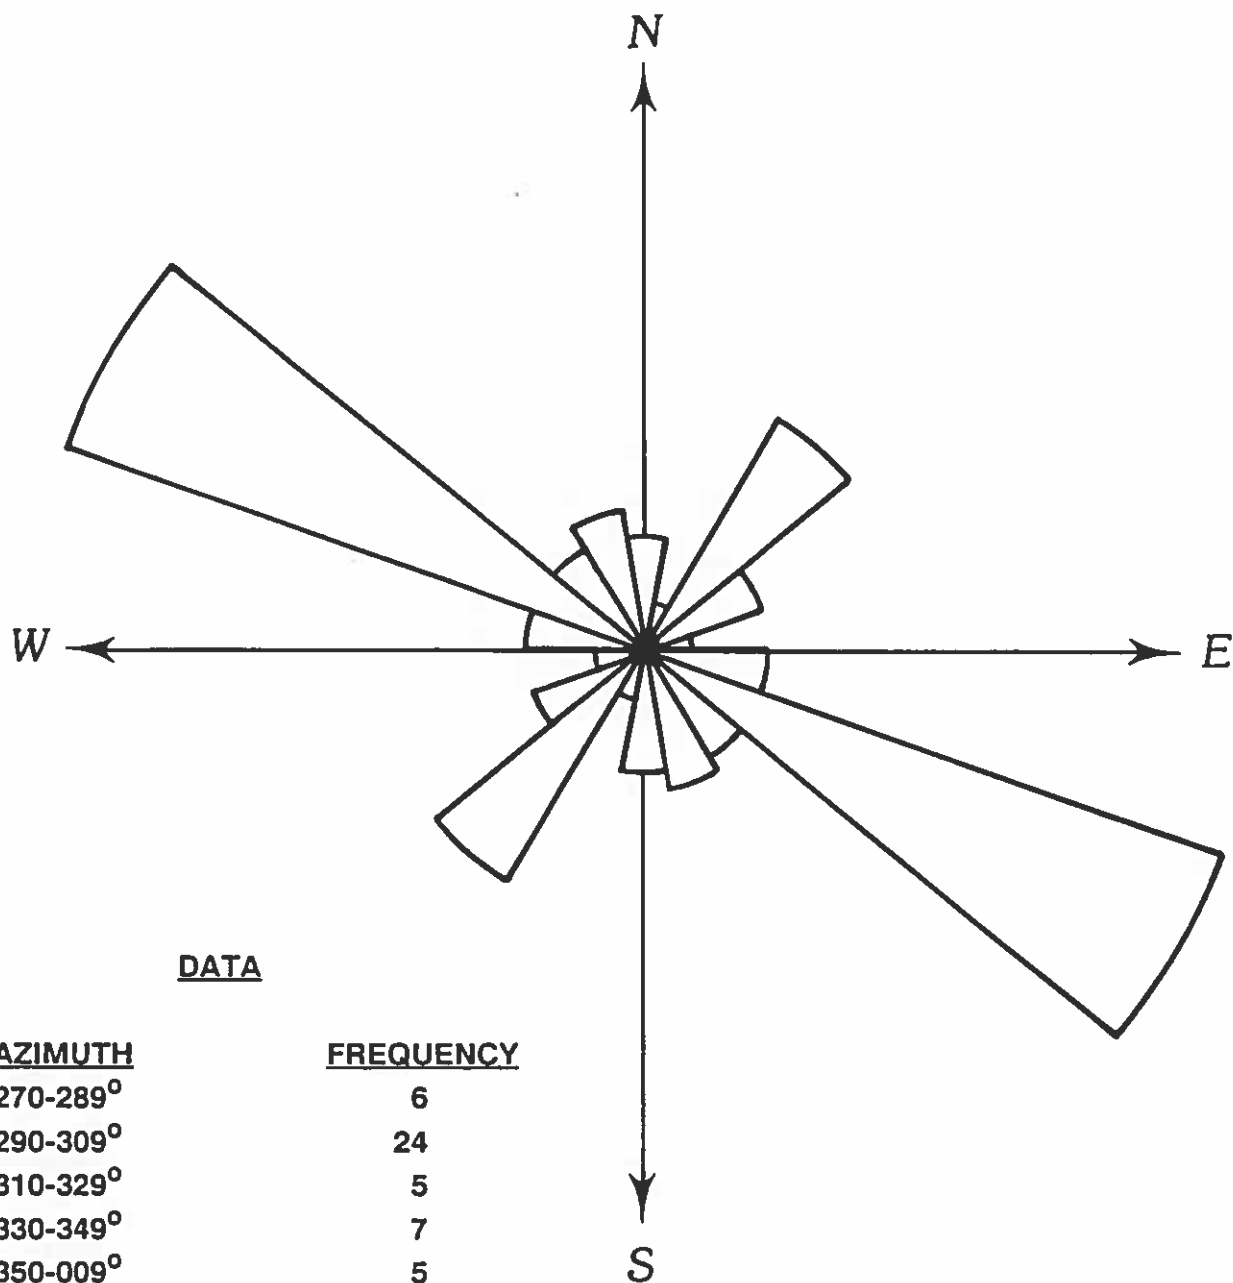
<u>AZIMUTH</u>	<u>FREQUENCY</u>
270-289°	6
290-309°	24
310-329°	5
330-349°	7
350-009°	5
010-029°	3
030-049°	14
050-069°	5
070-089°	<u>1</u>
	70

Most of the rock features measured are interpreted as joints. The joints are nearly all vertical in dip. Joint spacing is typically observed at one-meter intervals but also ranges up to three meters. Joint azimuths have been grouped into 20° increments and are plotted in a Rose Diagram (Figure 4.2). The dominant joint sets recognized are centered at 300° and 40°. The 300° joint set is nearly parallel to stream segments of the Brandywine Creek immediately upstream and downstream of the outcrop stations as well as the stream segment immediately upstream of the Brandywine/Hagley lineament. The 40° joint set is nearly parallel to the Brandywine/Hagley lineament.

joint sets, centered at 300° and 40°, respectively. The joint spacing is highly variable and irregular, and joints are typically spaced one meter (3.3 ft) apart. It appears that the joints are the predominant fracture type in these rocks, as there is little evidence for faulting or other non-joint fractures (although some horizontal fractures probably exist). Therefore, groundwater flow is presumably controlled primarily by the orientation of the joints, and secondarily by the orientation of other fractures.

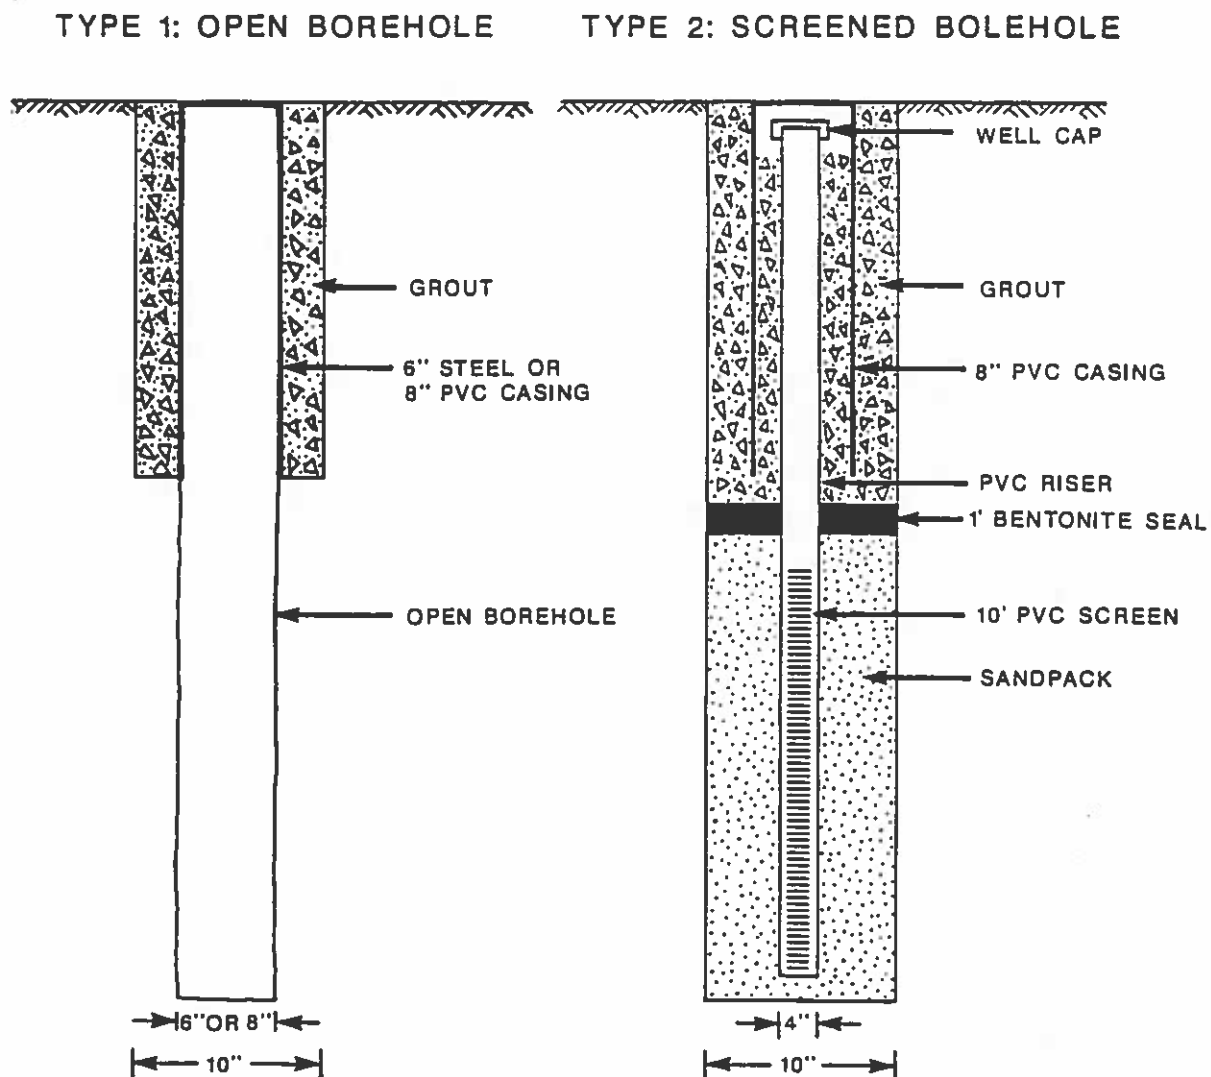
Figure 4.4. New monitor well construction specifications.

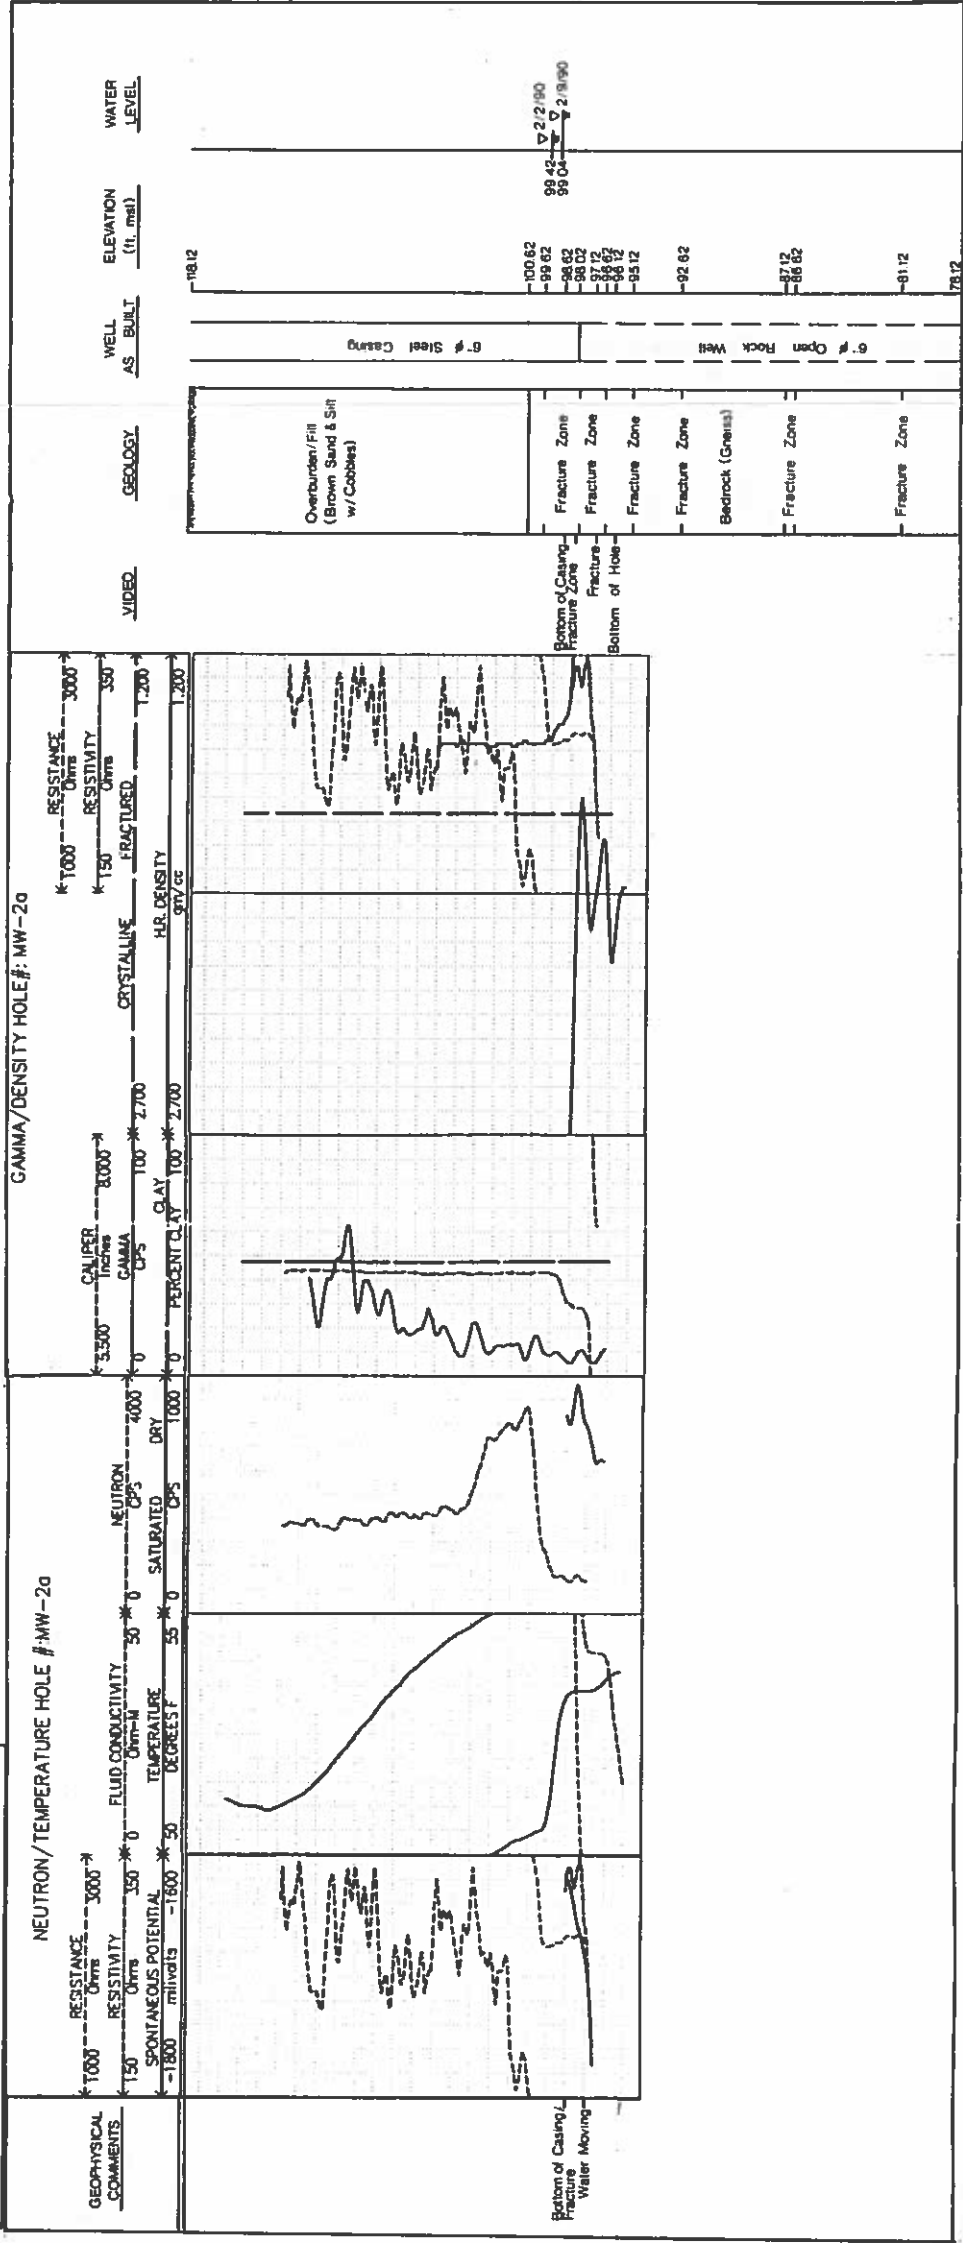
WELL: MW-2A
TOTAL DEPTH (ft. below ground surface): 40.0
TOP OF CASING ELEV. (ft. ms.): 120.03
HYDRAULIC CONDUCTIVITY (ft./day):
POSITIVE DISPLACEMENT: 10.66
NEGATIVE DISPLACEMENT: Not applicable

Figure 4.6. Summary of geologic information collected at monitor well MW-2A.

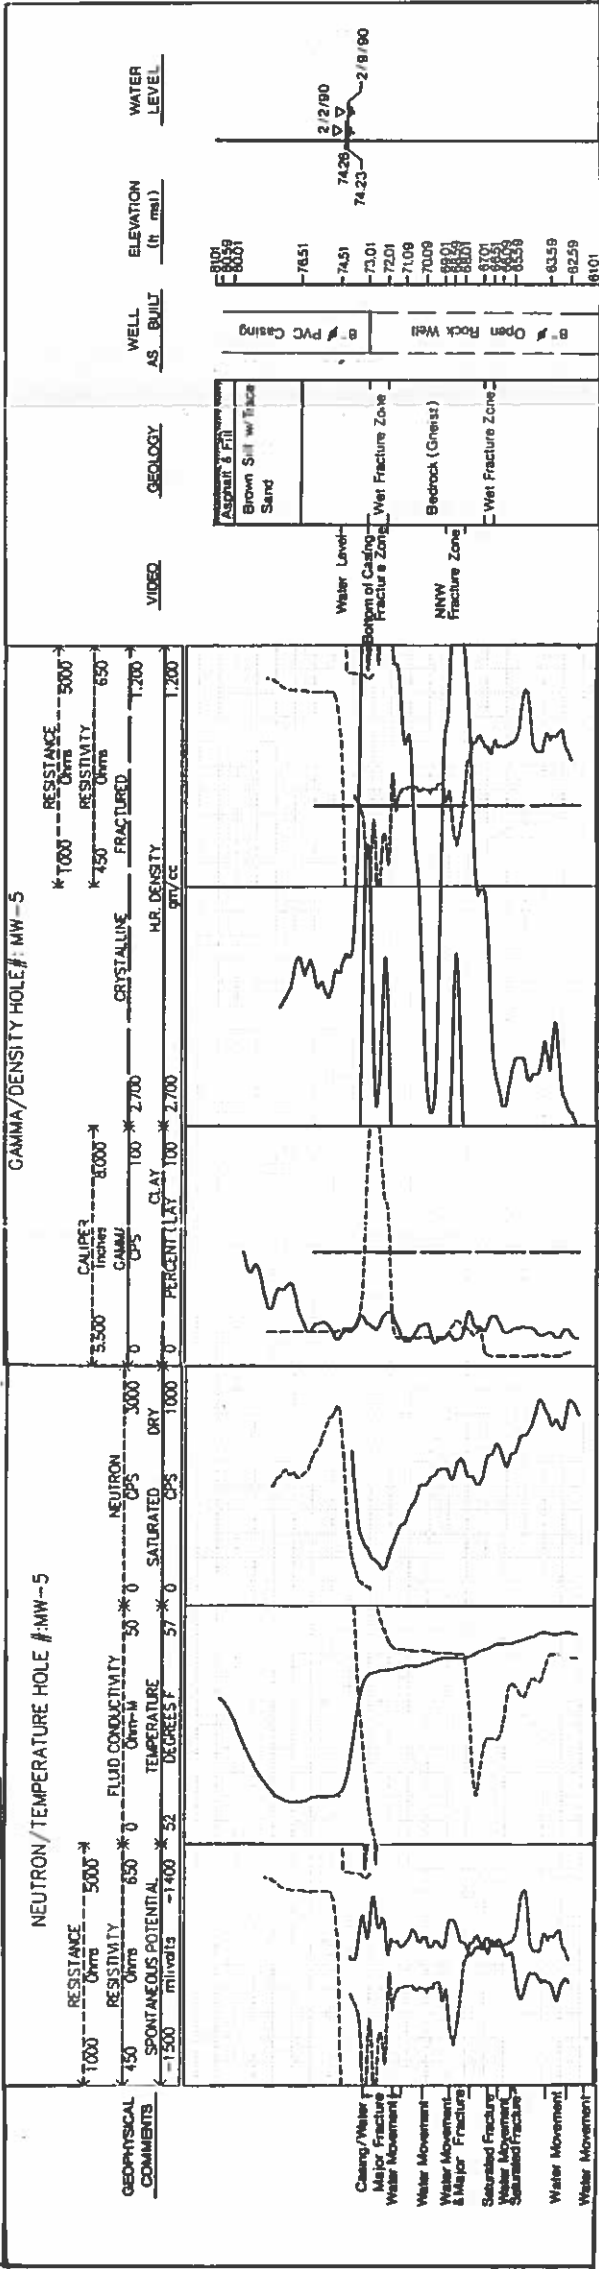
WELL MW-5
TOTAL DEPTH (ft below ground surface): 20.0
TOP OF CASING ELEV (ft. ms): 80.59
HYDRAULIC CONDUCTIVITY (ft./day): POSITIVE DISPLACEMENT: 9.20 NEGATIVE DISPLACEMENT: 3.29

Figure 4.10. Summary of geologic information collected at monitor well MW-5.

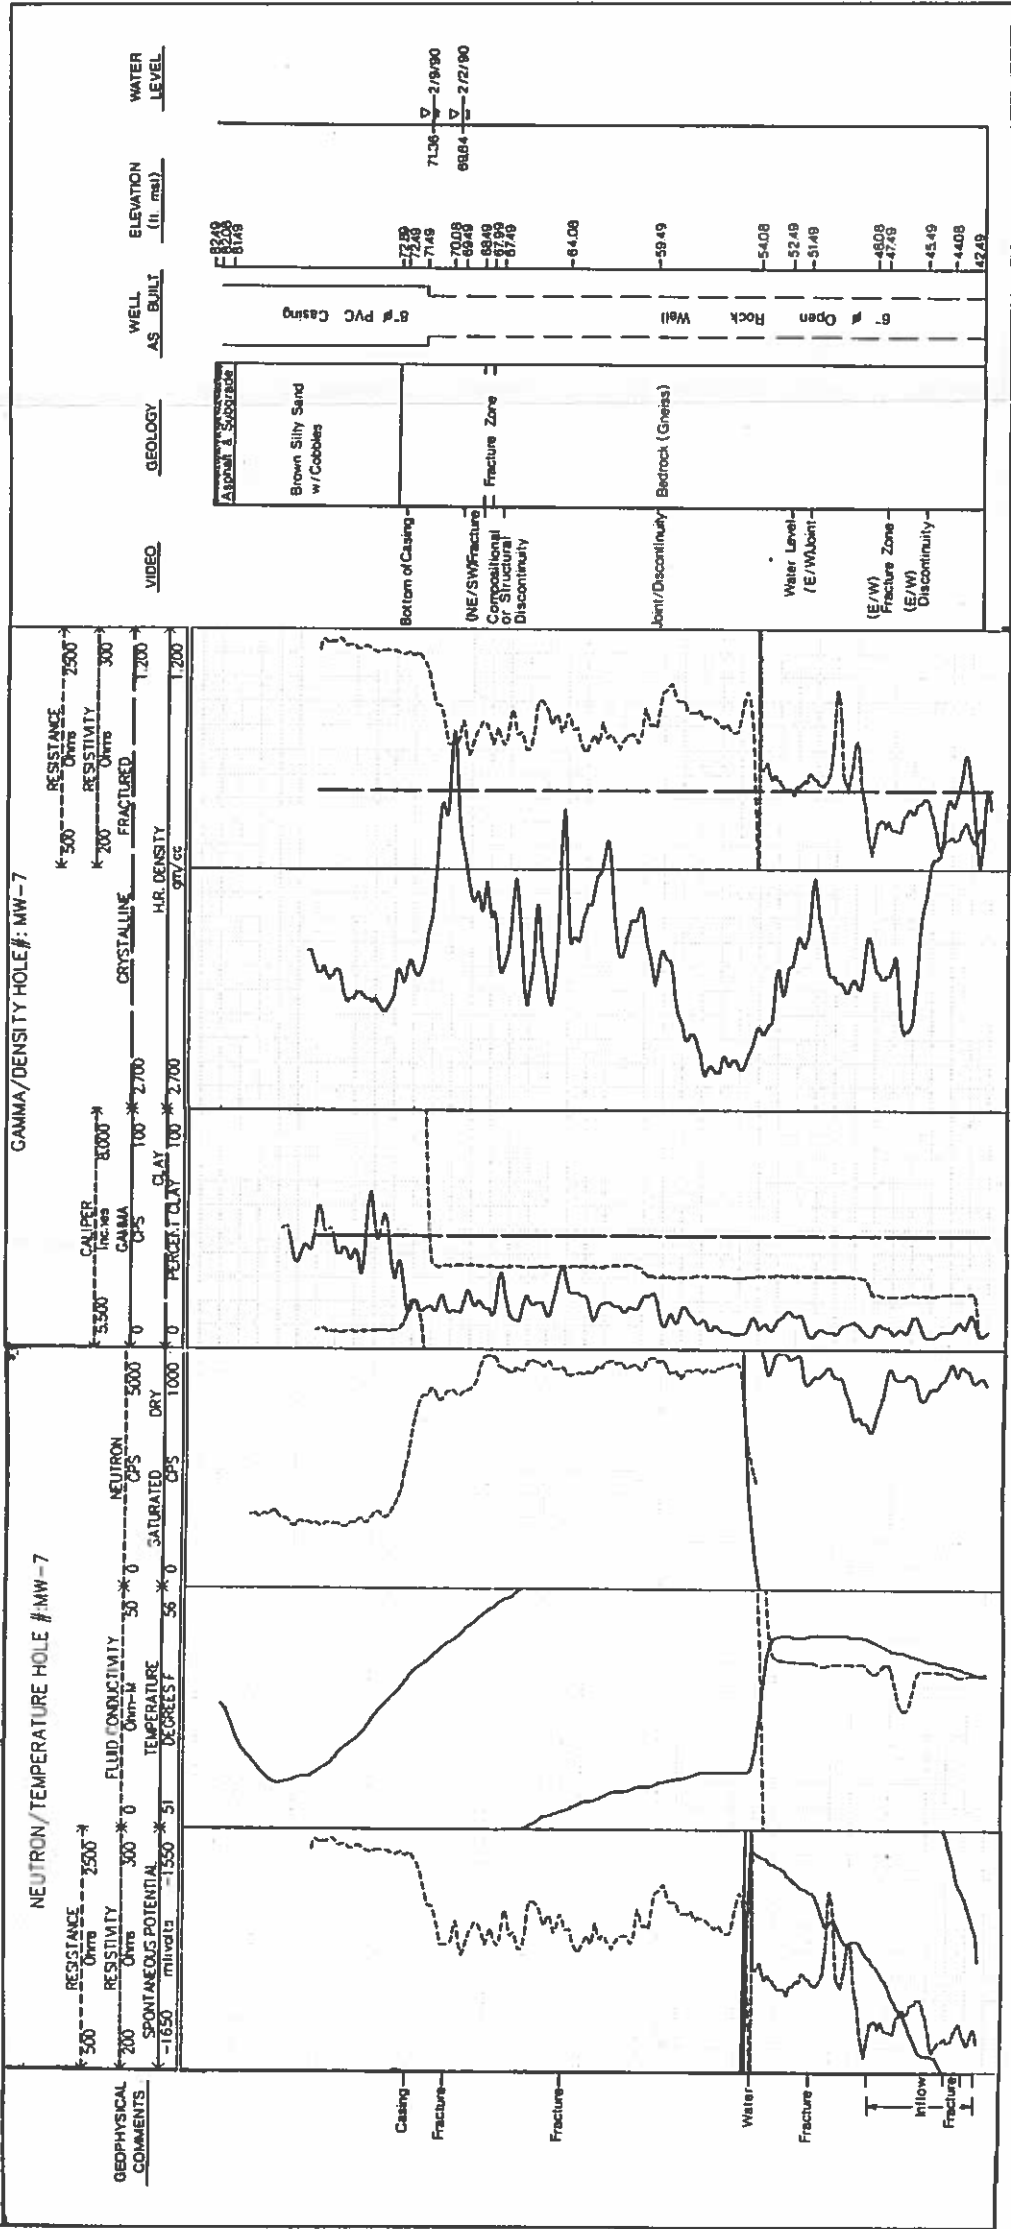
WELL MW-7
TOTAL DEPTH (ft below ground surface) 40.0
TOP OF CASING ELEV (ft. msl): 82.08
HYDRAULIC CONDUCTIVITY (ft./day)
POSITIVE DISPLACEMENT $\leq 5.9 \times 10^{-5}$
NEGATIVE DISPLACEMENT Not applicable

Figure 4.12. Summary of geologic information collected at monitor well MW-7.

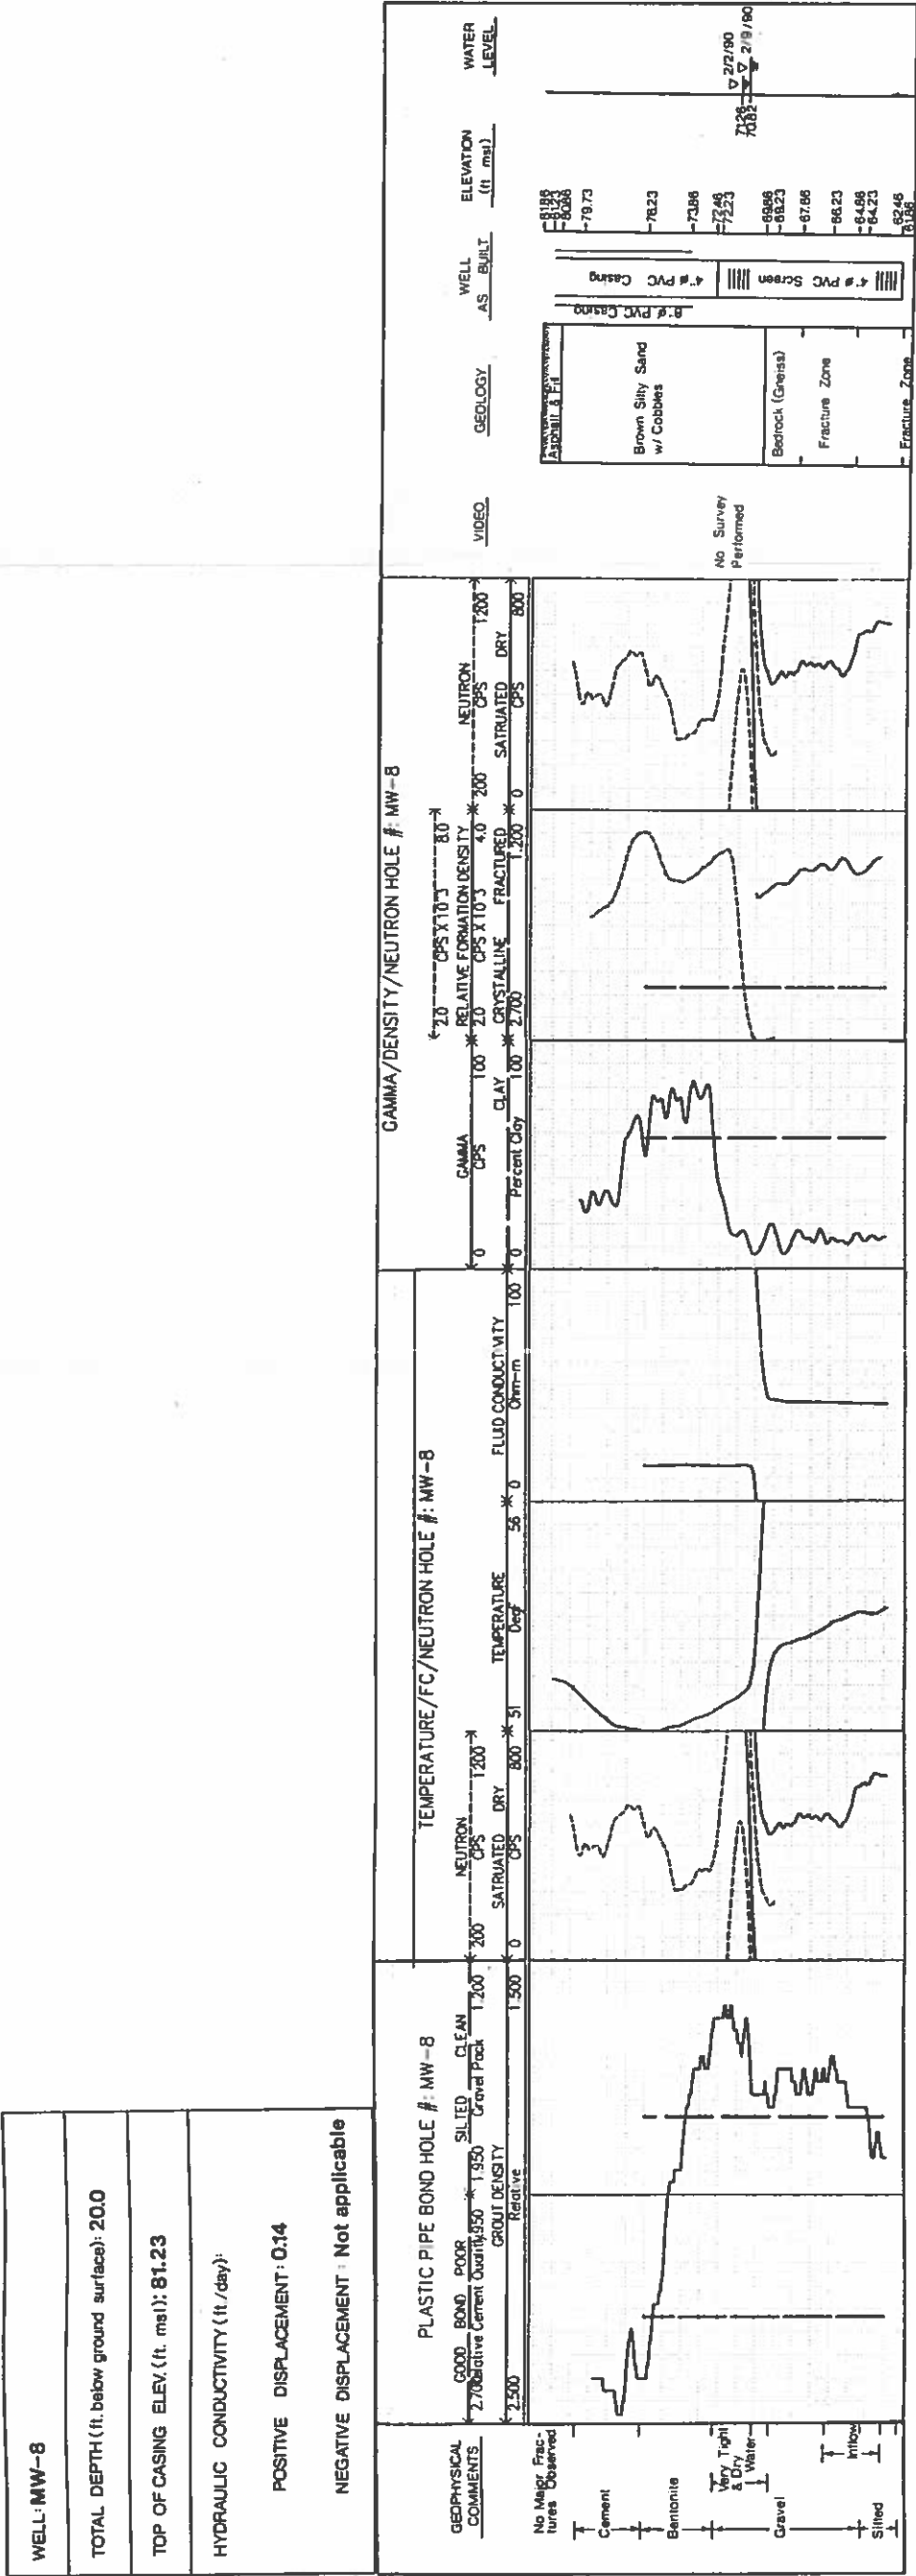
Figure 4.13. Summary of geologic information collected at monitor well MW-8.

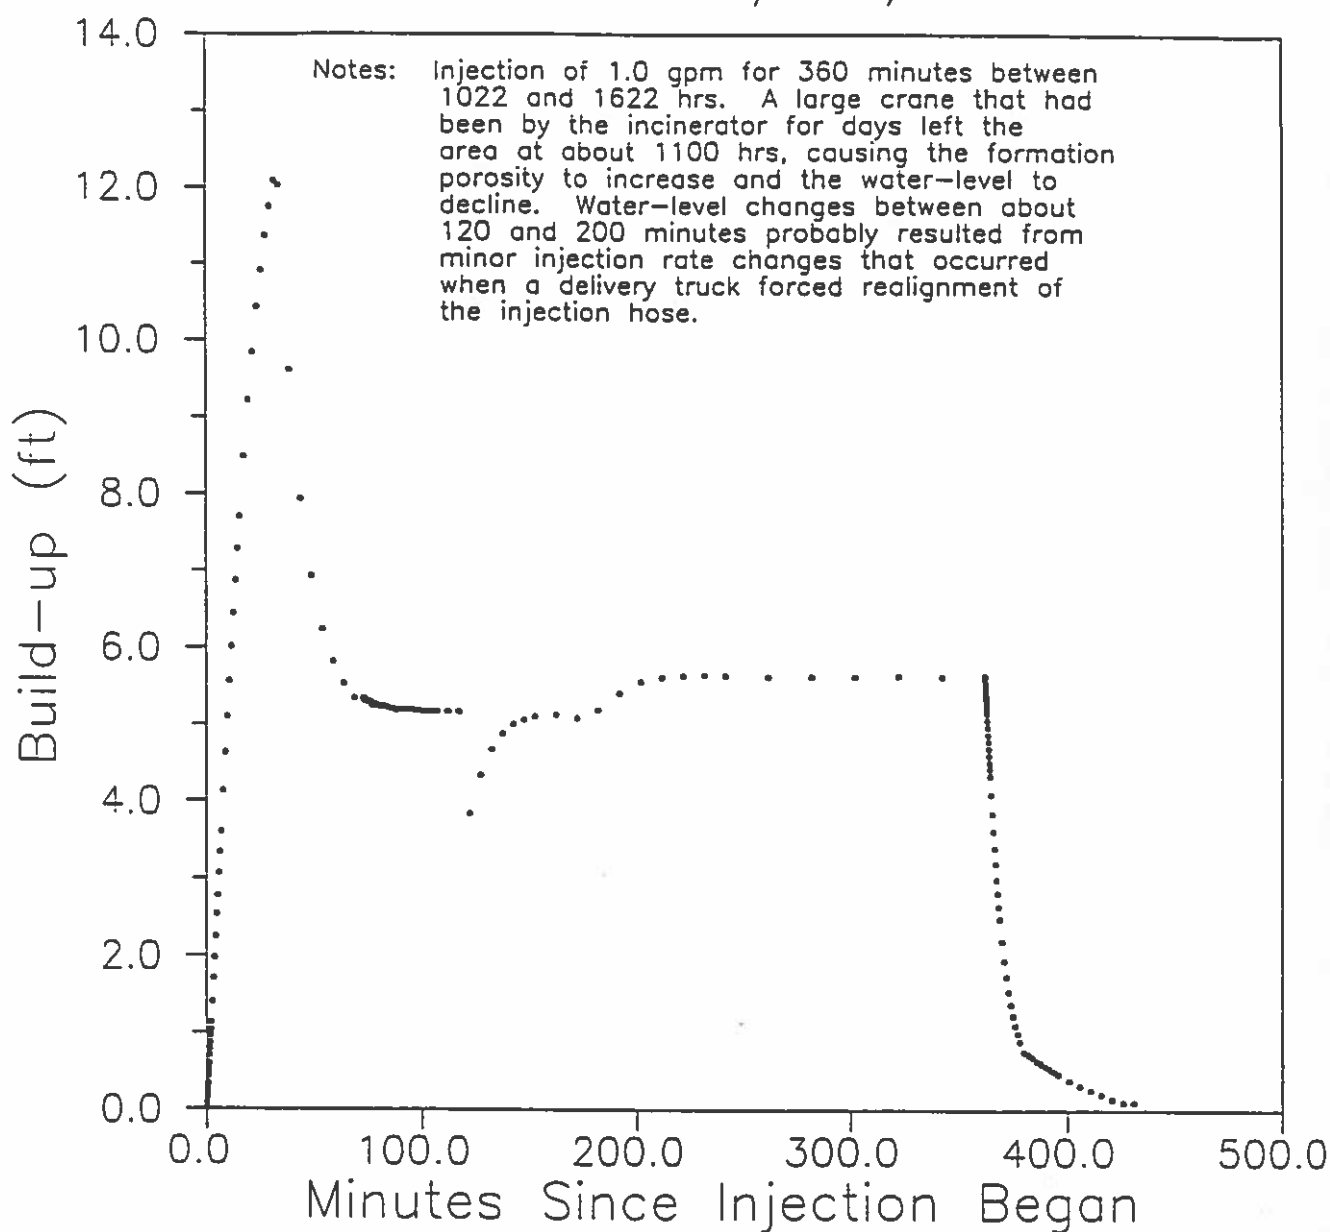
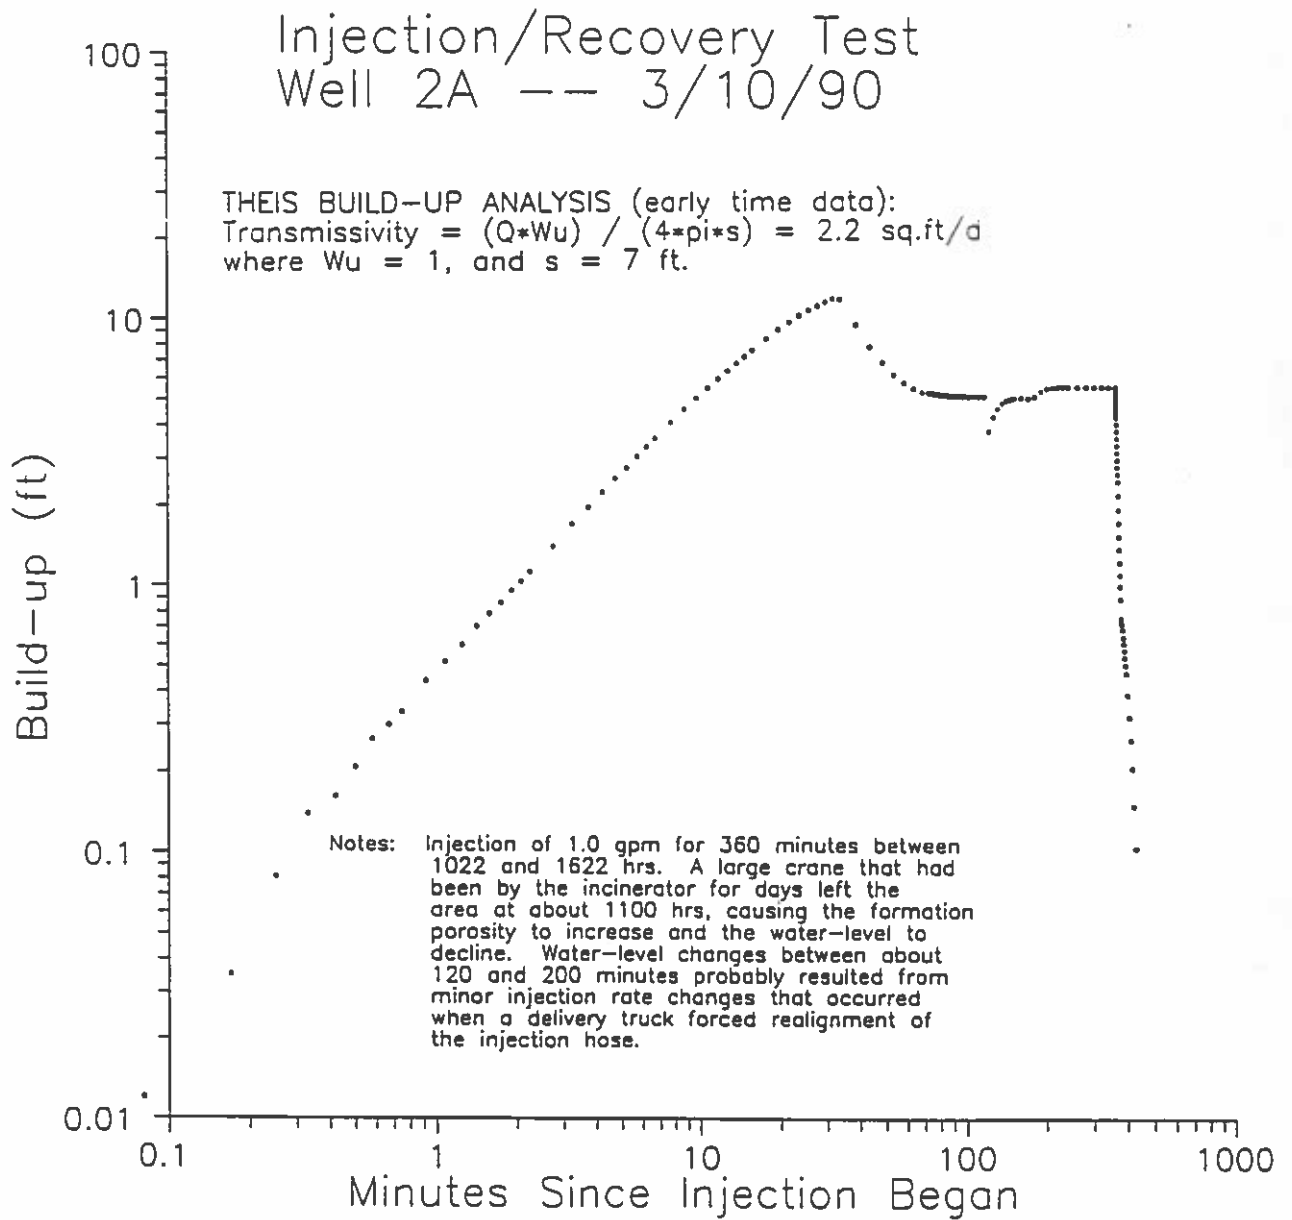
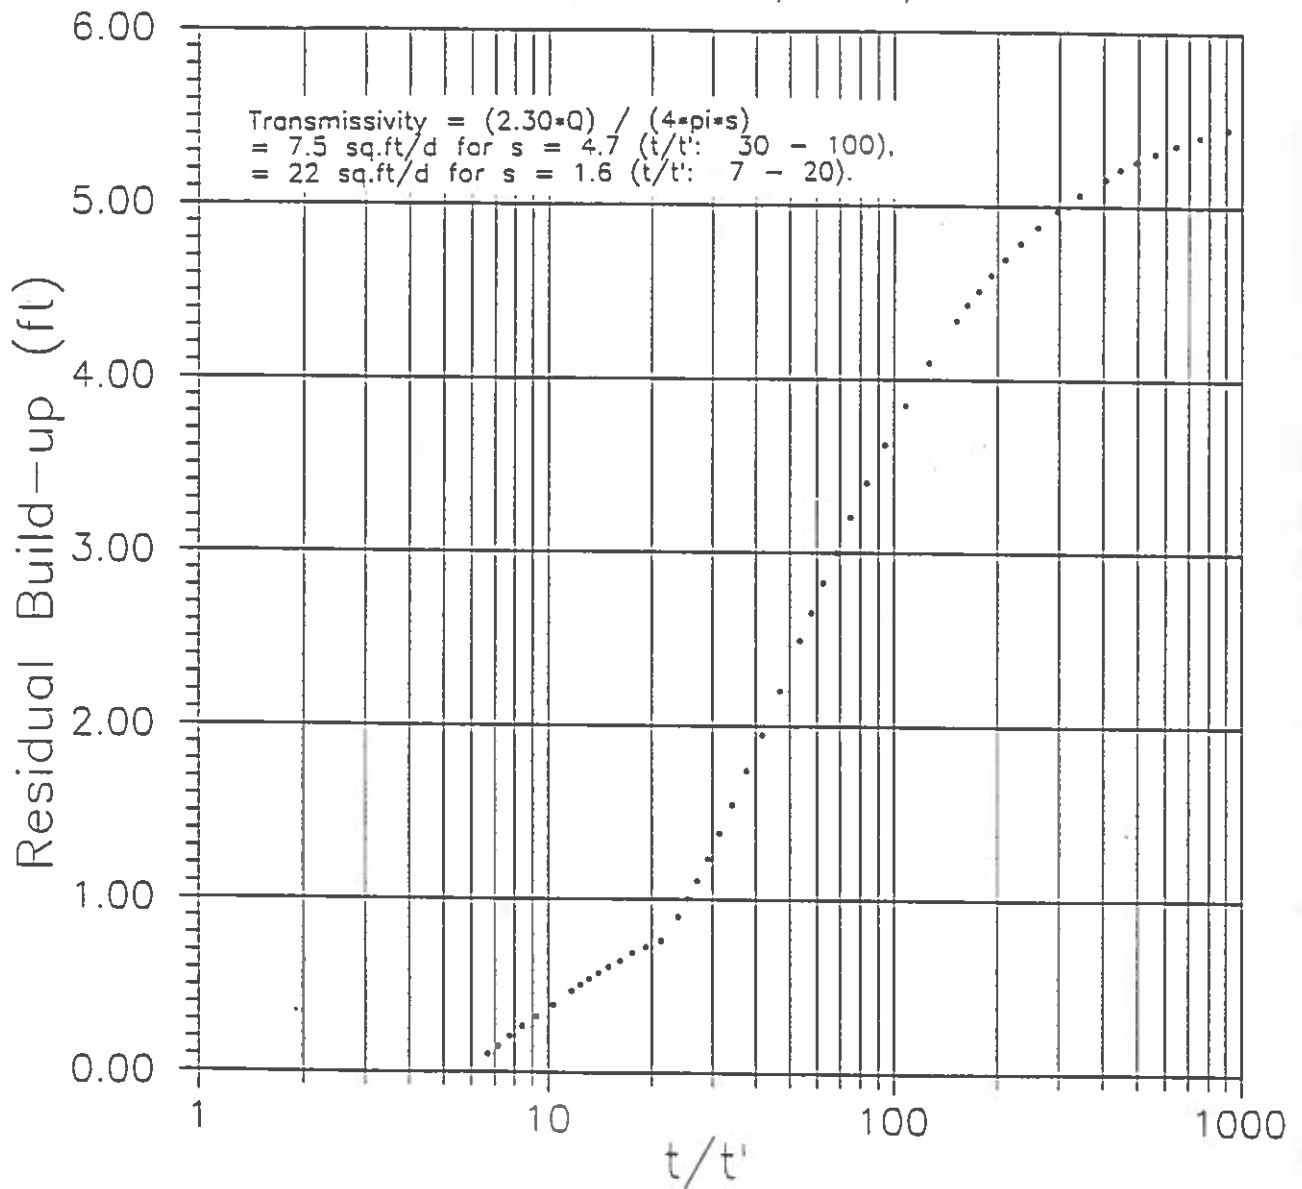
Figure 4.17a. Pumping test results at well MW-2A.

Figure 4.17b. Pumping test results at well MW-2A.

# Theis Recovery Analysis Well 2A — 3/10/90

Figure 4.17c. Pumping test results at well MW-2A.
